Dam Safety Risk Analysis and Risk Management Practices at the Bureau of Reclamation

Scott Stevens, P.E.

Technical Specialist, Technical Service Center
Denver Colorado

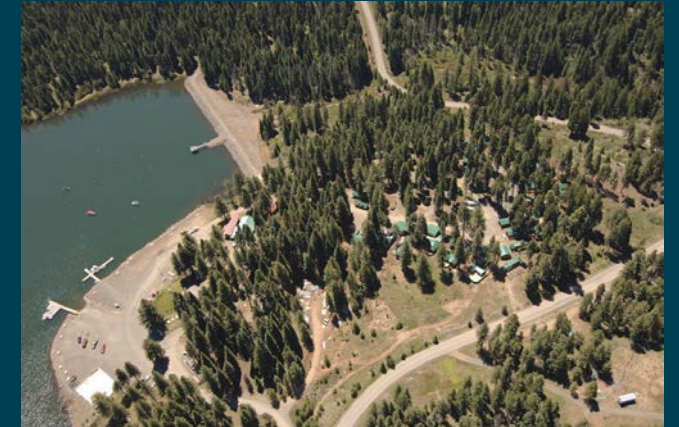
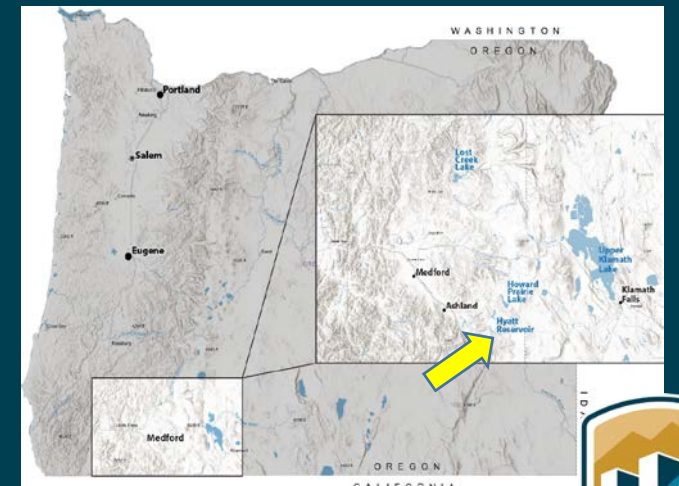
Example: Modification of Hyatt Dam, Oregon

- Small embankment dam constructed in 1922 by the local irrigation district (title eventually transferred to Reclamation)
- Generally constructed as a homogeneous rolled earth embankment
 - Some use of puddled fill
- Design included a concrete-pipe toe drain surrounded by “loose rock”
- Design included a small cast-in-place core wall along the base of the cutoff trench

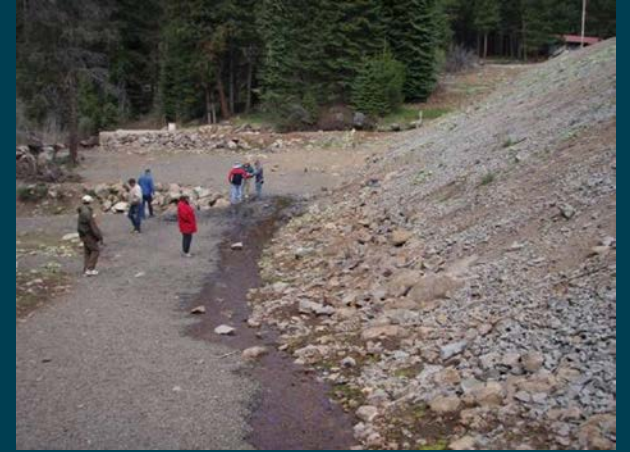
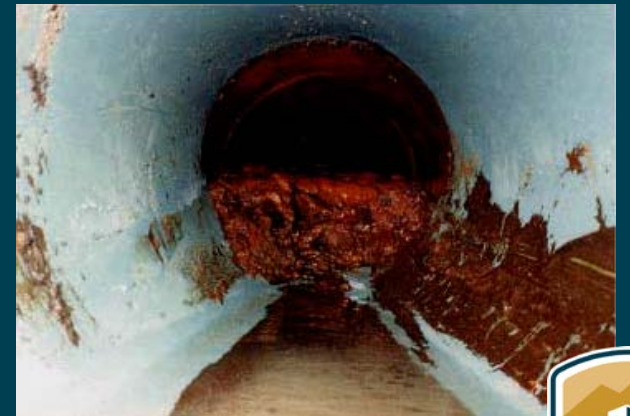
Example: Modification of Hyatt Dam, Oregon

- No adverse performance observations were reported over the first 50 years
- Seepage along the left abutment began to be observed in the 1970s
- Toe drain flows dropped abruptly in 2009, with new seepage areas subsequently reported
- An inspection was performed and revealed that the toe drain pipe was damaged and deteriorated in some places

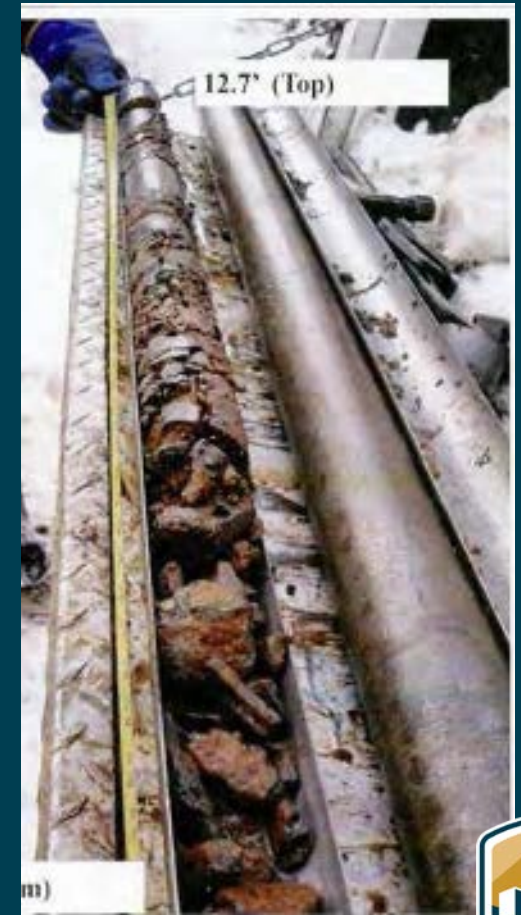
Example: Modification of Hyatt Dam, Oregon

- The investigations revealed wet seams in the embankment as well as fractured rock in contact with the overburden beneath the downstream shell
- The elevations of these features corresponded to reservoir water surface (RWS) elevations where seepage changes occurred
- The Issue Evaluation risk team concluded that while the damaged toe drain was a contributor, the risks of the key PFM's would remain high if the toe drain was simply replaced

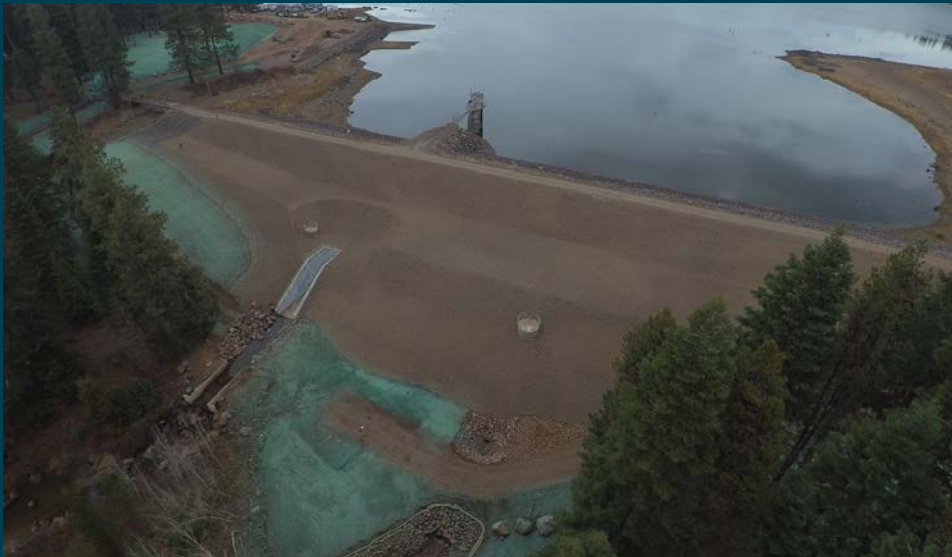
Example: Modification of Hyatt Dam, Oregon

- The Issue Evaluation indicated a relatively high risk of failure, with relatively high confidence in the overall portrayal of risk
- Recommendation was made to proceed into a corrective action study
- Dam was modified in 2017 to reduce the risk of internal erosion

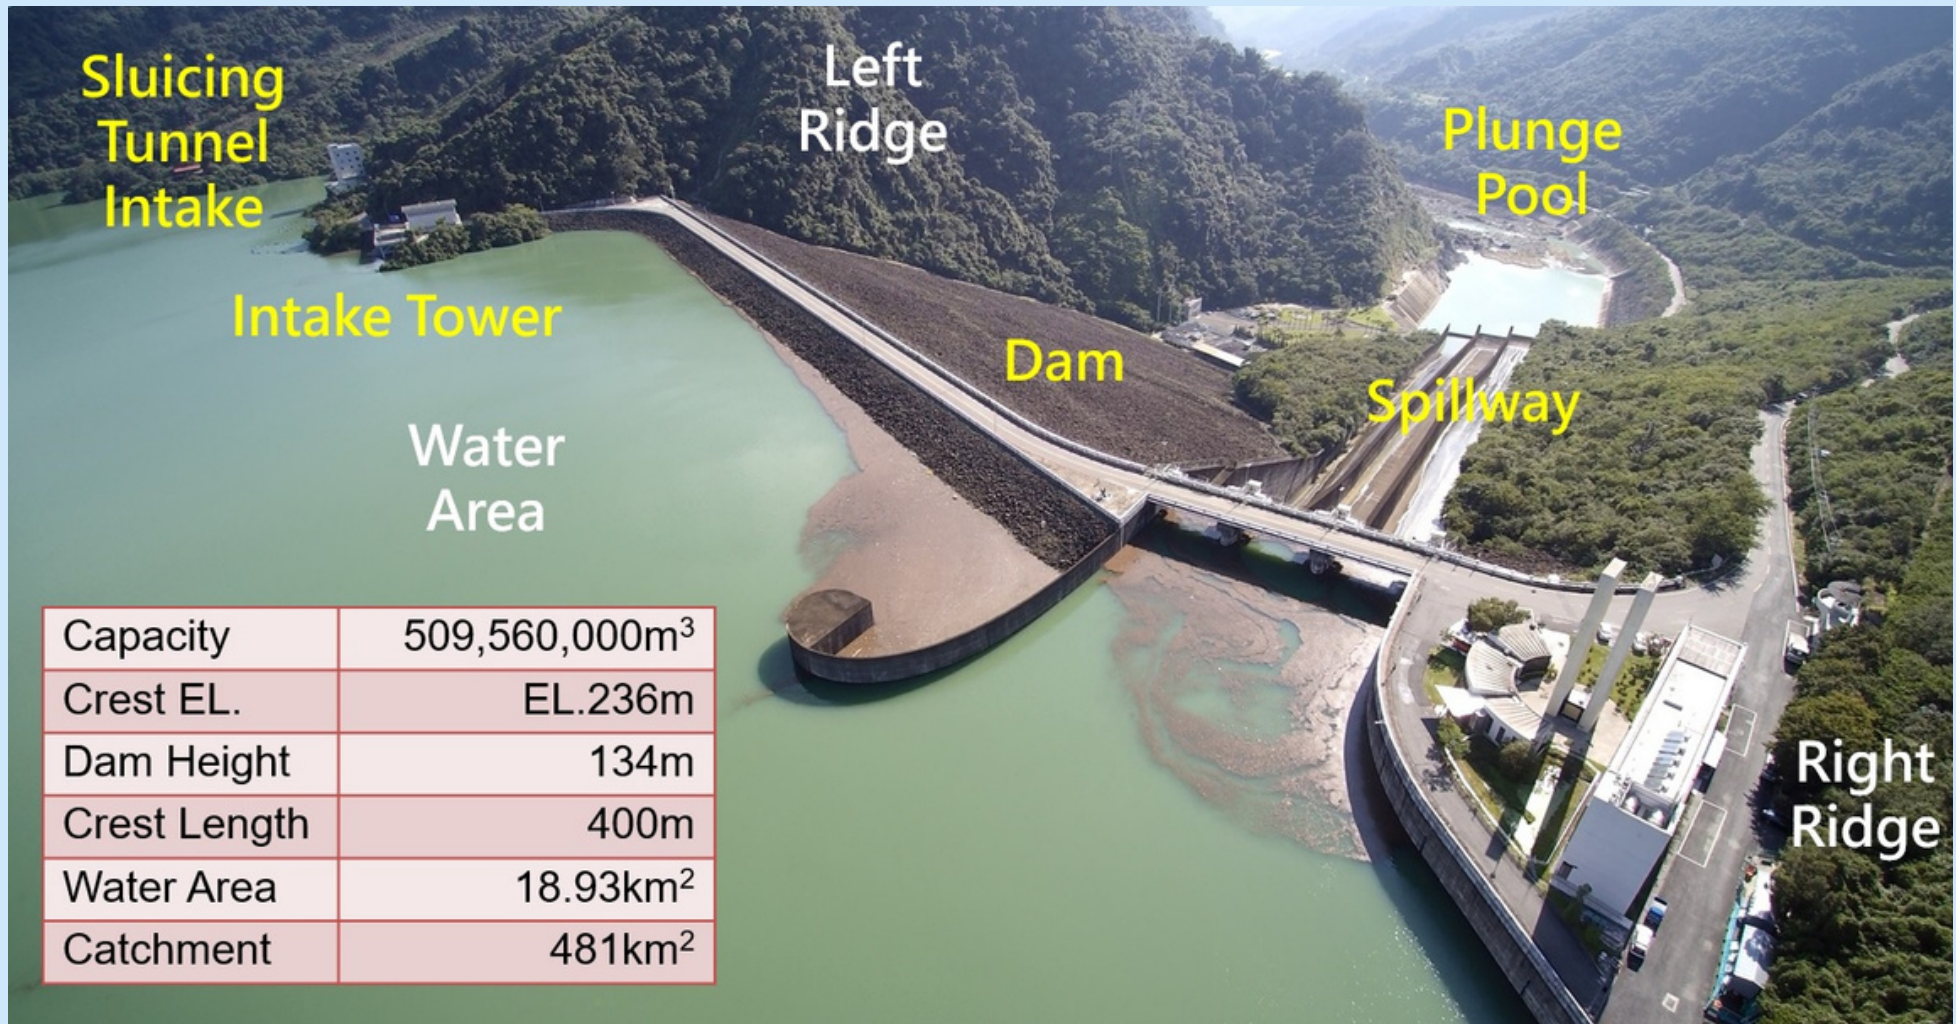
Capacity	509,560,000m ³
Crest EL.	EL.236m
Dam Height	134m
Crest Length	400m
Water Area	18.93km ²
Catchment	481km ²

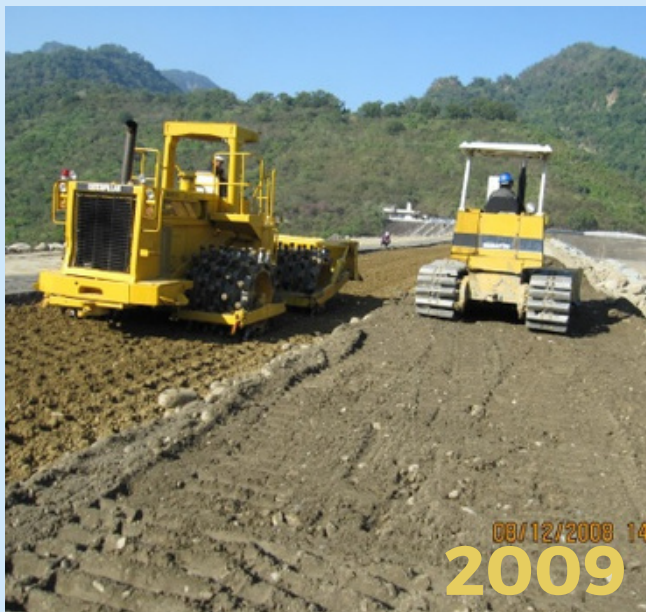
CORE HEIGHTENING

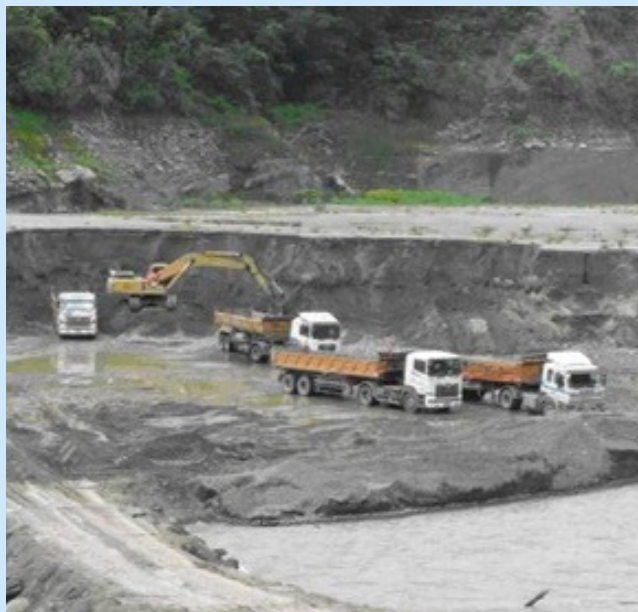
EXCAVATION

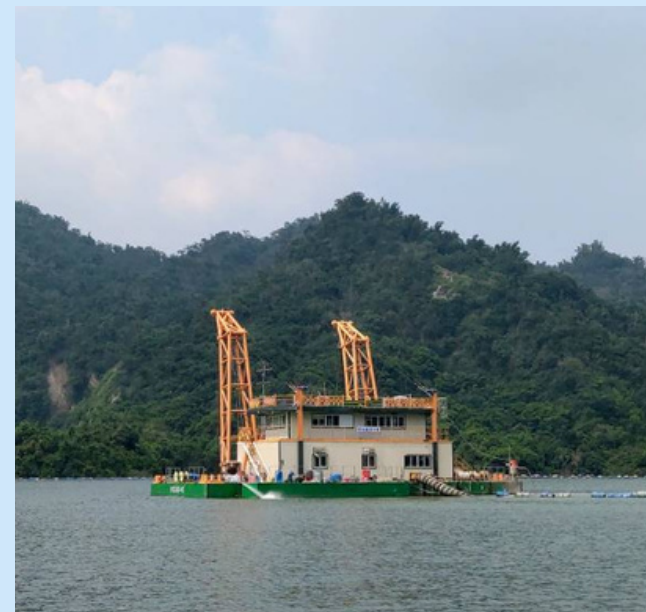
HYDRAULIC DREDGING

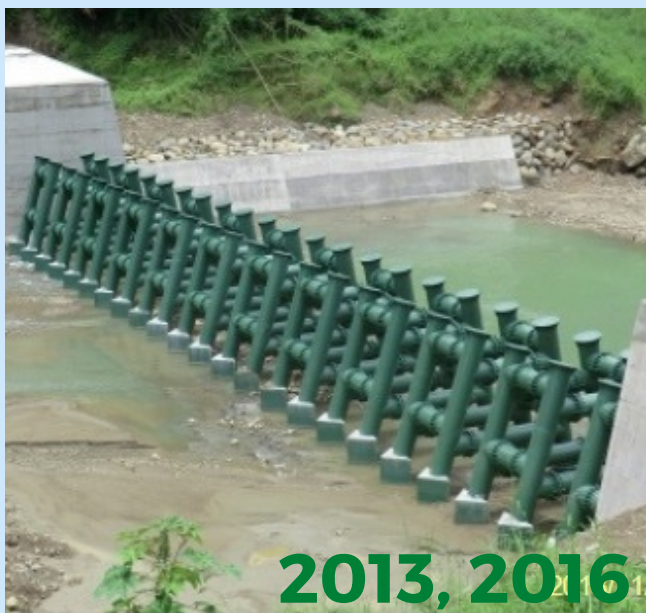
INTERCEPTING

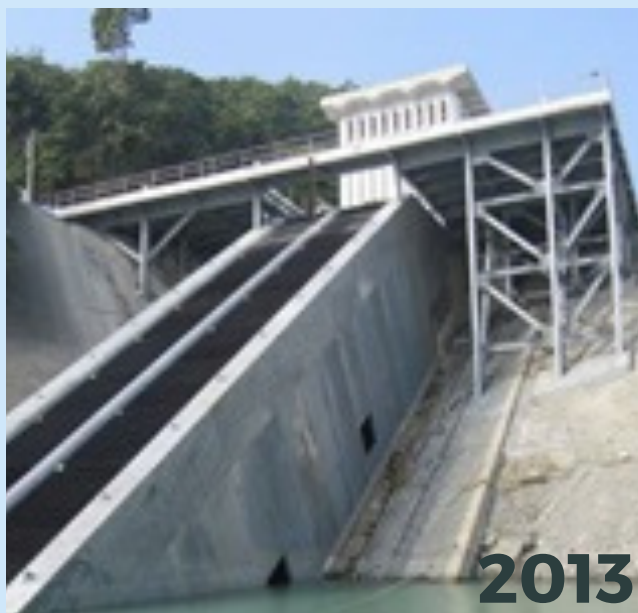
INTAKE EXTENDING

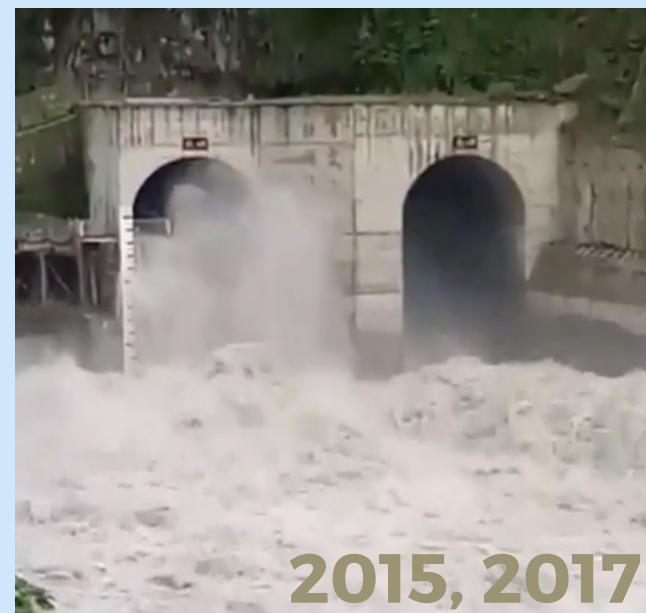
SLUICING/FLUSHING

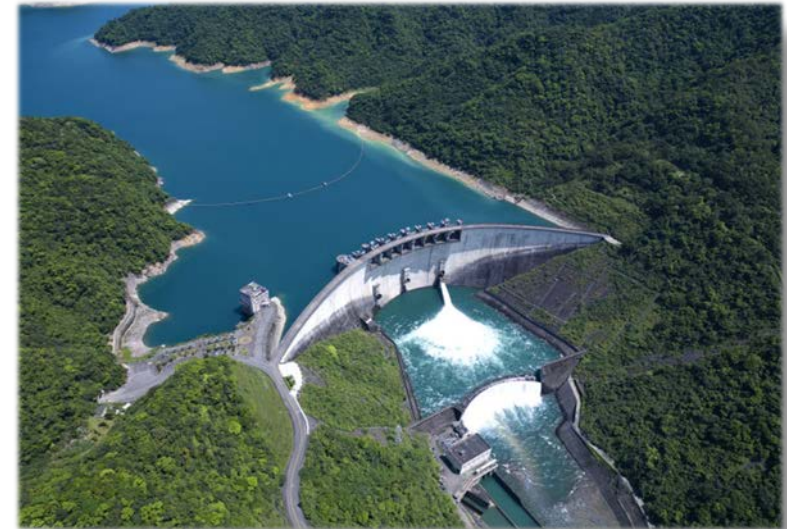
- The Feitsui Dam is a three-centered double curvature and variable thickness concrete arch dam
 - ➡ The reservoir capacity is the largest of all concrete dams in Taiwan
- It was completed in 1987 and only 30 km away from Taipei city
- The dam is 122.5 meters high and 510 meters long from the crest, with a volume of 700,000 cubic meters of concrete
- More than 4 million people living in the downstream area

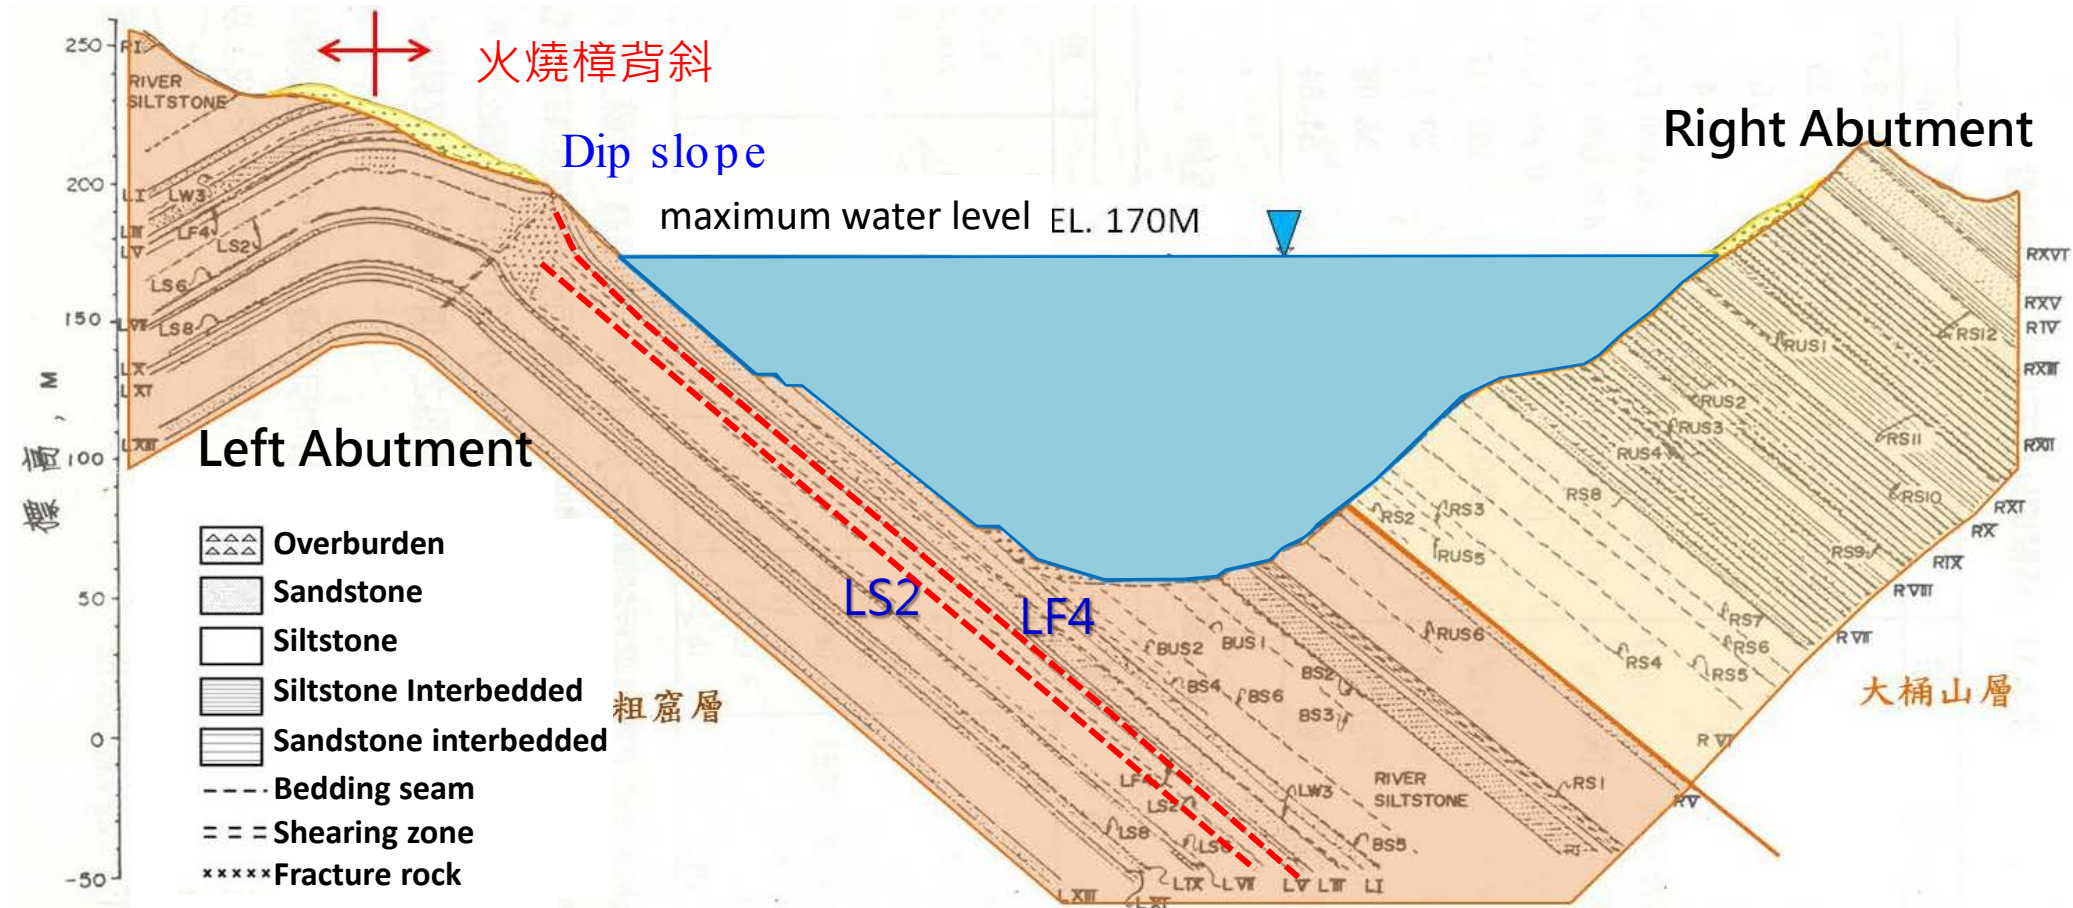
Geology condition of Feitsui Dam

- 🌐 **Special seam treatments were conducted during the construction of the dam to improve the shear strength and the deformability of the left abutments**

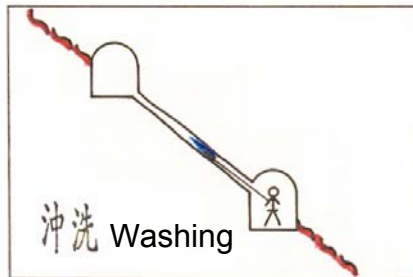
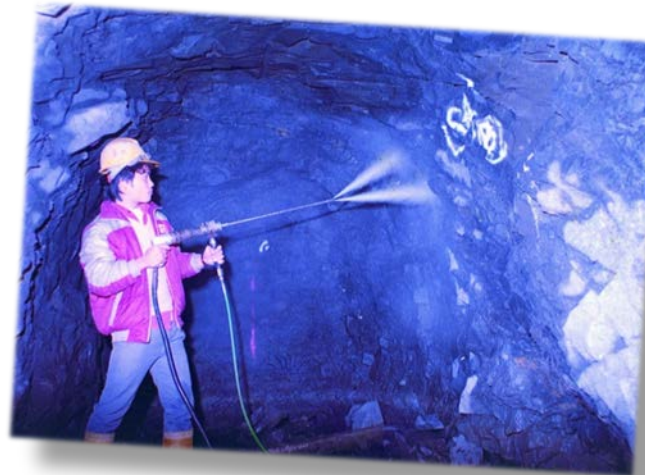
Foundation Treatment

- Cleaning the clay seams with high pressure water jets and then backfilled with non-shrinking cement mortar
